Manhole Inspection Summary

Manhole # S41E__040MH

Insp Date: **2/19/09 1:18 PM**

Location Address: **4 S CENTRAL AVE**

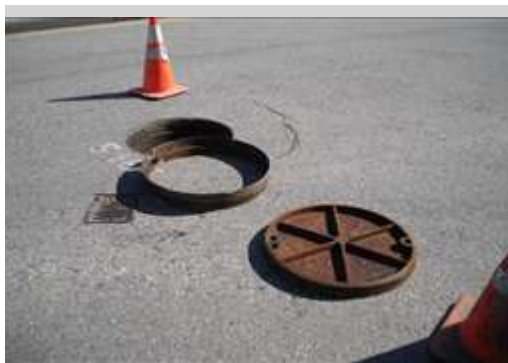
Miscellaneous

Comments **OBSERVED THAT MH LID WAS STUCK IN ADJUSTABLE FRAME. LIFTED OUT FRAME AND REMOVED LID BY USING 16LB SLEDGE. CLEANED INSIDE OF FRAME AND REPLACED ADJUSTABLE FRAME. PLACED NEW 24" LID BY REI/DRAYCO. INSPECTION COMPLETE.**

LOOSE ADJUSTABLE FRAME CAME UP WITH MH COVER

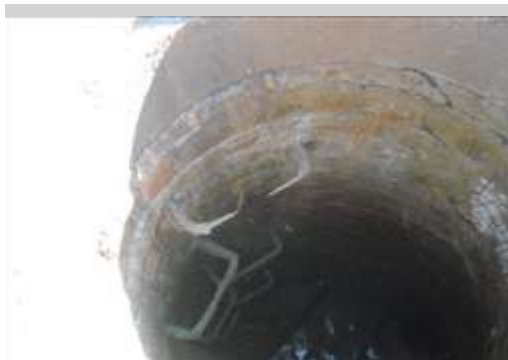
Defect 1

Count: **5** Missing: **1** ☒ **Corroded**

BROKEN TOP STEP DUE TO CORROSION

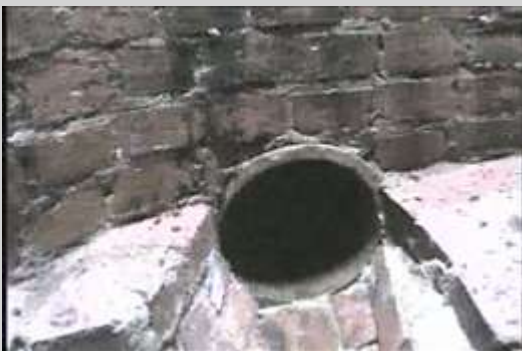
3 O'Clock Inflow

Pipe Height: **9.6** (in.) Rod and Bar (Angled)
Pipe Material: **Clay** ☐ Pipe Lined
Invert Depth: **11.53** (ft.) Flow Characteristics: **Slow**
Deposits: ☒ None ☐ Mud ☐ Sludge ☐ Debris ☐ Grease
Silt Depth: **0** (in.) Deposits Extent:
Infiltration: **None** Pipe Seal Cond: **Cracked**

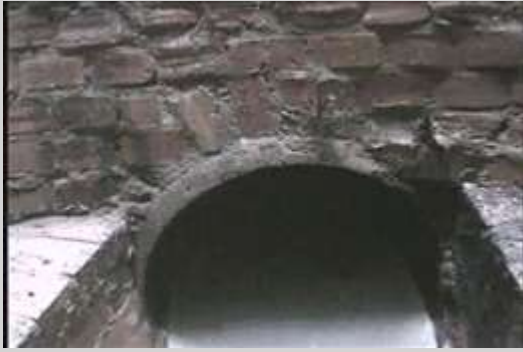
6 O'Clock Inflow

Infiltration: **None** Pipe Seal Cond: **Cracked**
